II. Water Quality Status, Water Quality Issues and Areas of Concern

1. Water Quality Status

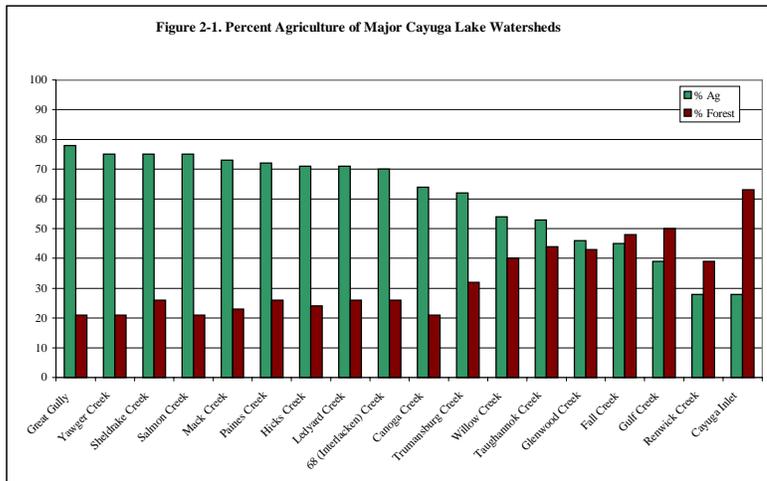
Land use is also a factor in sediment loss. Agriculture, an important land use throughout the watershed, is most concentrated in the northern two-thirds of the watershed, on both the eastern and western shores. As displayed in Figure 2-1, active agriculture ranges from more than 70% of the land area in Great Gully and Yawger Creek to less than 30% in Cayuga Inlet.

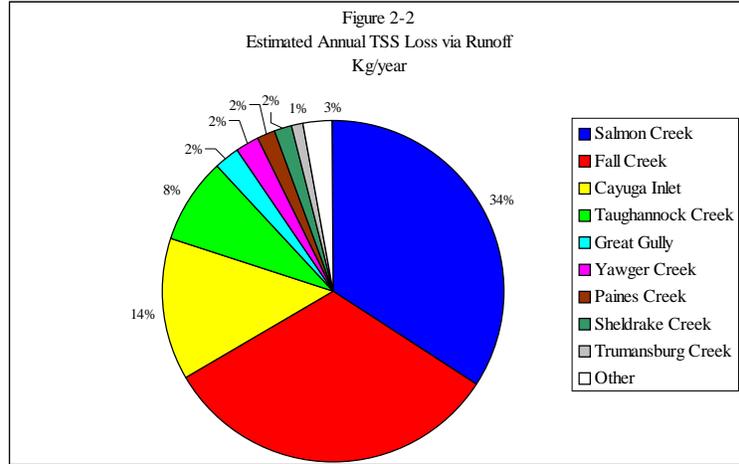
Simple loading models have been developed to estimate sediment loss based on land use and hydrologic conditions. As part of the technical analysis completed for the RPP, annual average sediment loss from agricultural runoff was estimated for the major subwatersheds in the Cayuga Lake basin. These results, displayed in Figure 2-2, provide a basis for defining priority areas. The importance of Salmon Creek, a relatively large subwatershed with a high percentage of the land area in active agricultural use, is evident. However, monitoring is needed to confirm the findings (a recommendation to install a stream gauge on Salmon Creek is included in the Monitoring & Assessment section).

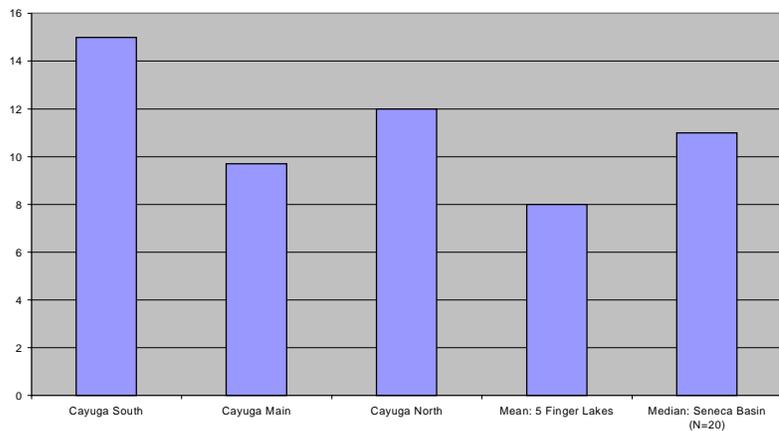
Figure 2-3 Total Phosphorus Concentrations, Summer Average Upper Waters

Data: Cayuga South Cornell Lake Source Cooling, 1999-2000
 Other Data: NYSDEC, 1996-1999
 5 other large Finger Lakes include Seneca, Skaneateles, Owasco, Canandaigua, Keuka

An estimated phosphorus budget for the southern lake basin would include the two streams and two wastewater treatment plants. In addition, phosphorus drawn from deep in Cayuga Lake is returned to the shallow southern basin by Cornell’s Lake Source Cooling project (see Figure 2-3). This industrial cooling water return flow represents a new source of phosphorus to southern Cayuga Lake during May – October when the lake does not naturally mix.
